Conettix Alarm Communications Troubleshooting Flowchart

Table of Contents

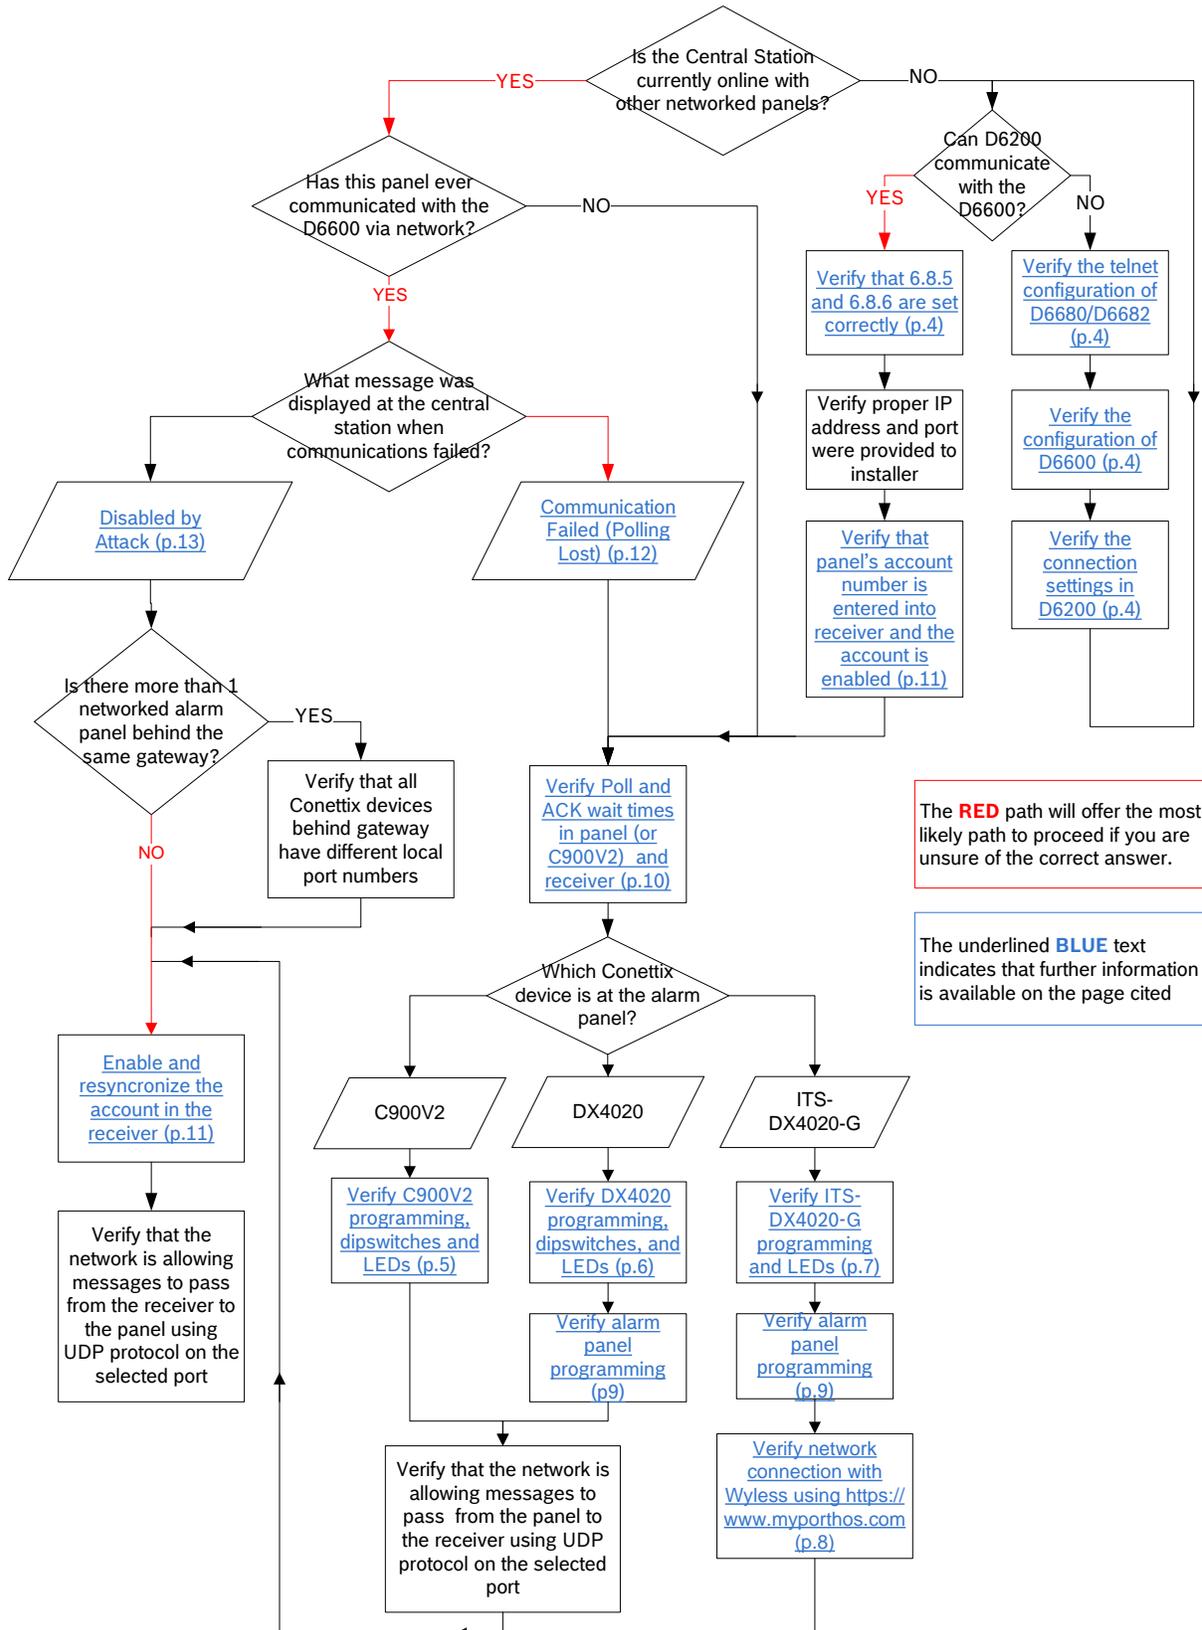
The **RED** path will offer the most likely path to proceed if you are unsure of the correct answer.

The underlined **BLUE** text indicates that further information is available on the page cited
